TECHNOLOGY INSERTION-ENGINEERING SERVICES
PROCESS CHARACTERIZATION
TASK ORDER NO. 1

VOLUME III
OC-ALC
BOOK 1 OF 2

CONTRACT SUMMARY REPORT AND QUICK FIX PLAN

15 DECEMBER 1989

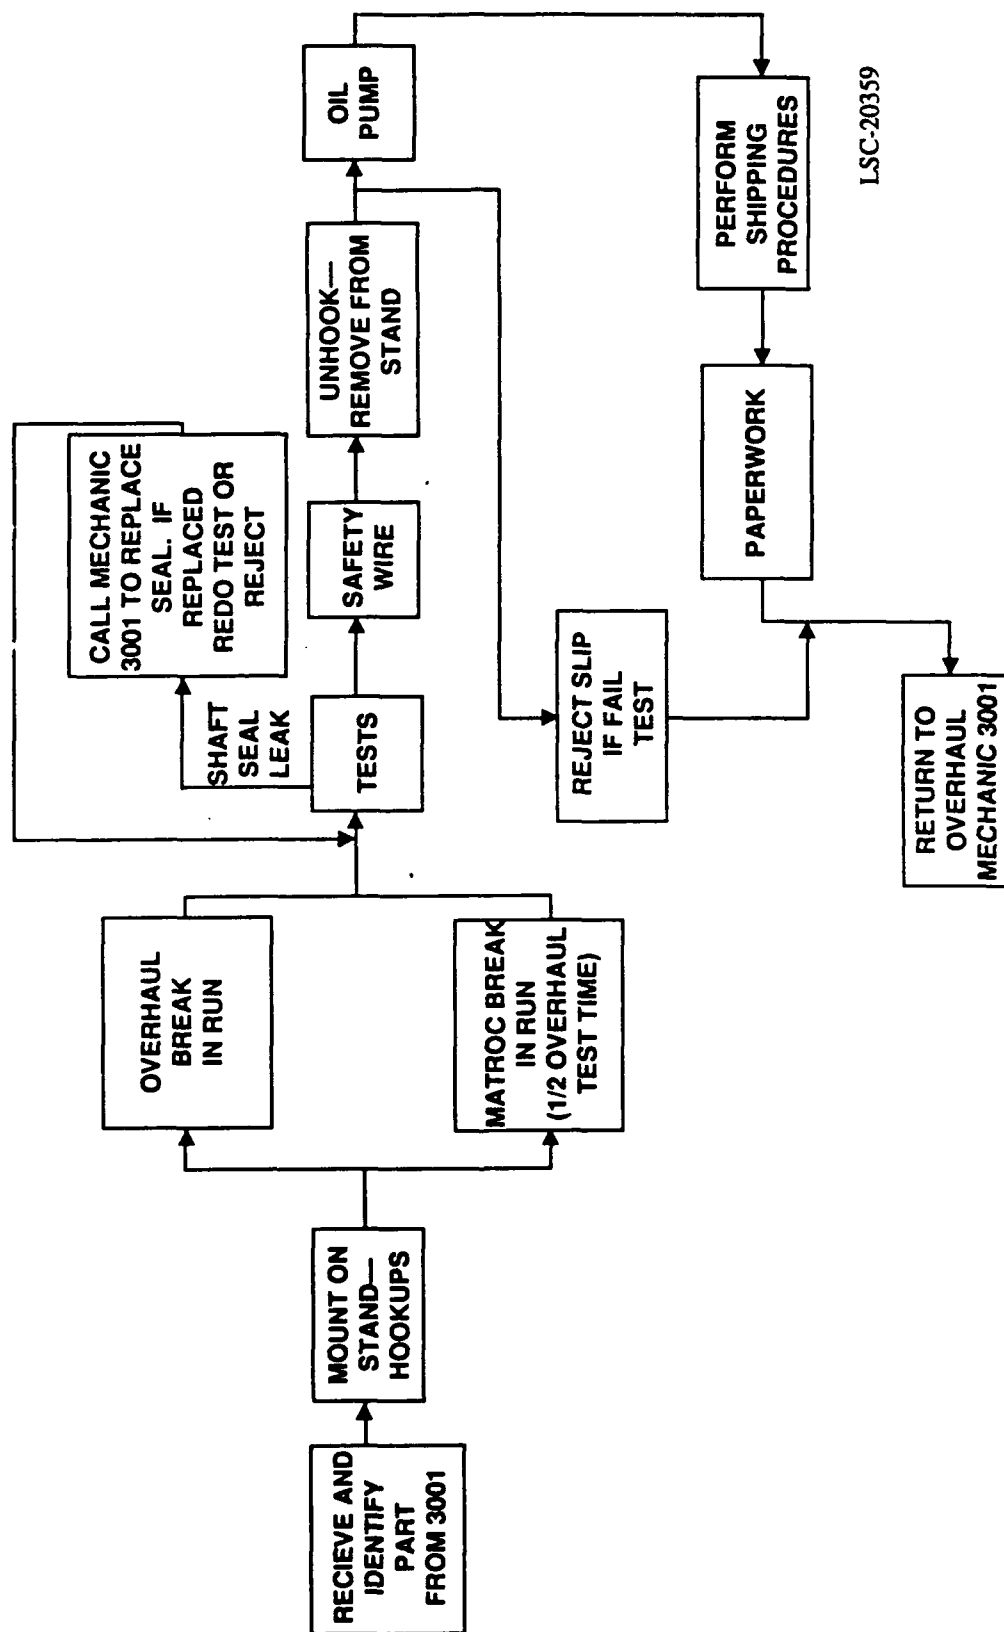
MATPCB FUEL PUMPS (TEST) PROCESS CHART
FIGURE 6.7.1-6

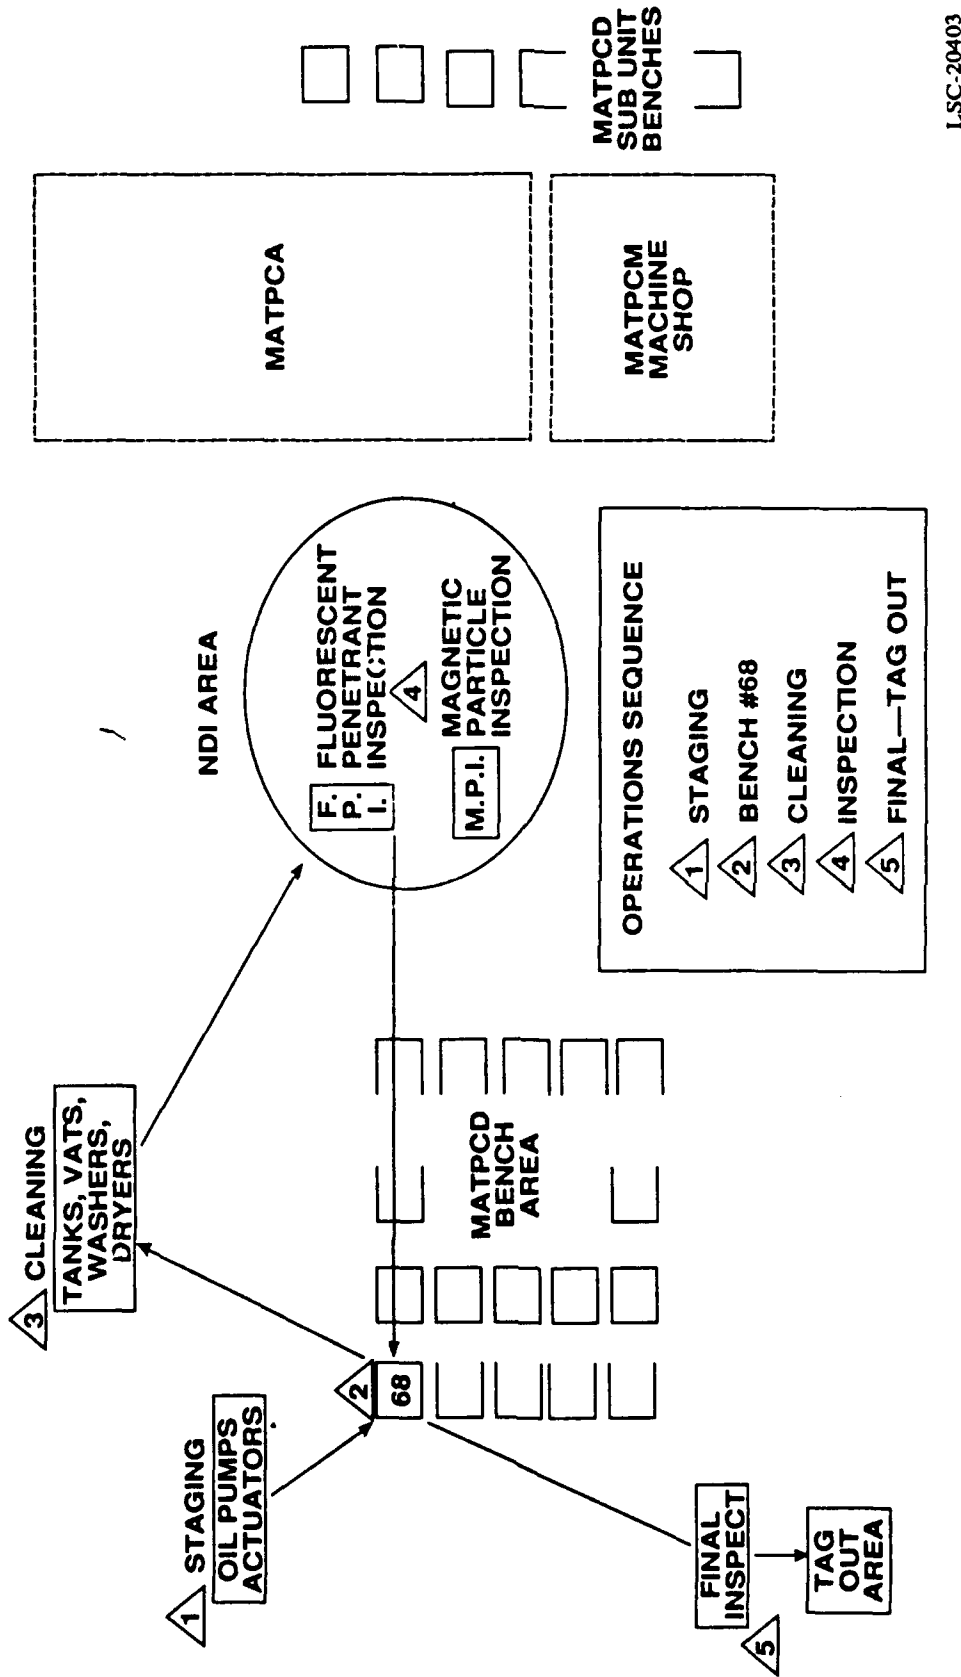
WORK AREA LAYOUT AND WORK FLOW FOR PCN 38680A (CONTROL BOX ASSEMBLY)

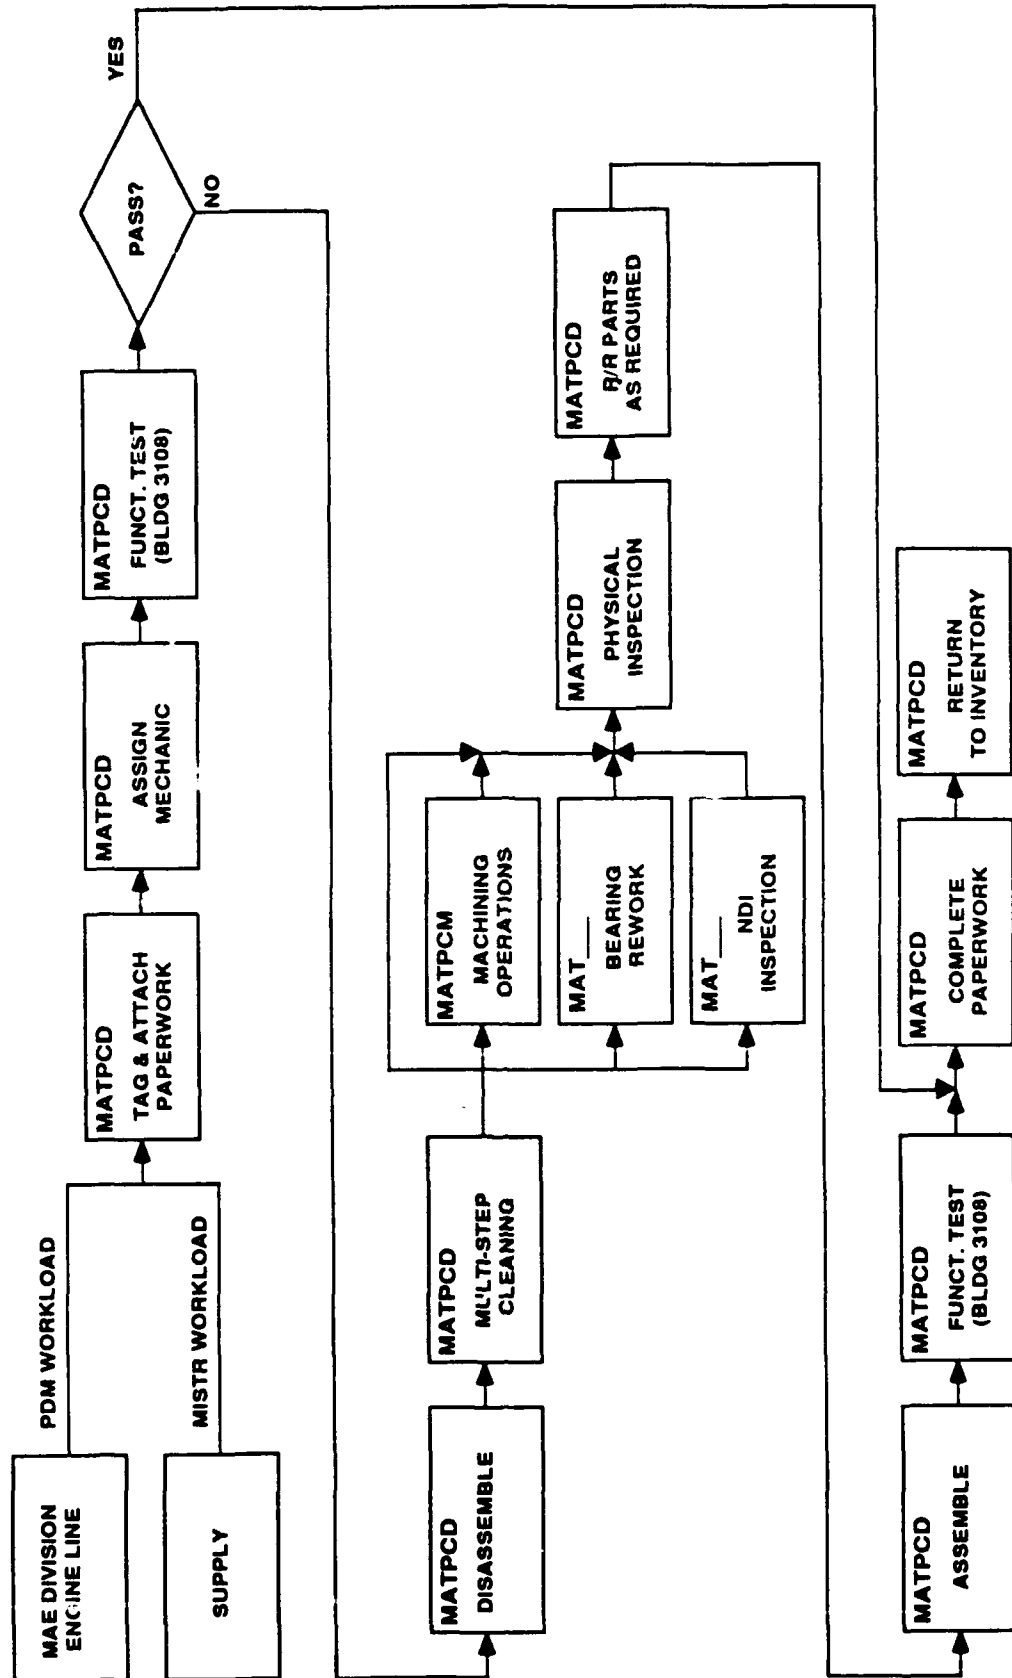
LSC-20400

MATPCD ENGINE ACCESSORIES PROCESS CHART (GOVERNORS)

Although this RCC processes a wide variety of end items, there is considerable commonality in process flow and technology. The process flow diagrams for governors (Figure 6.9.1-2), filters and oil pumps (Figure 6.9.1-3), and nozzle controls and actuators (Figure 6.9.1-4) are provided as examples of the major process flow schemes utilized by this RCC. These three process flow diagrams present all processes and technology required for MATPCD to accomplish its mission.

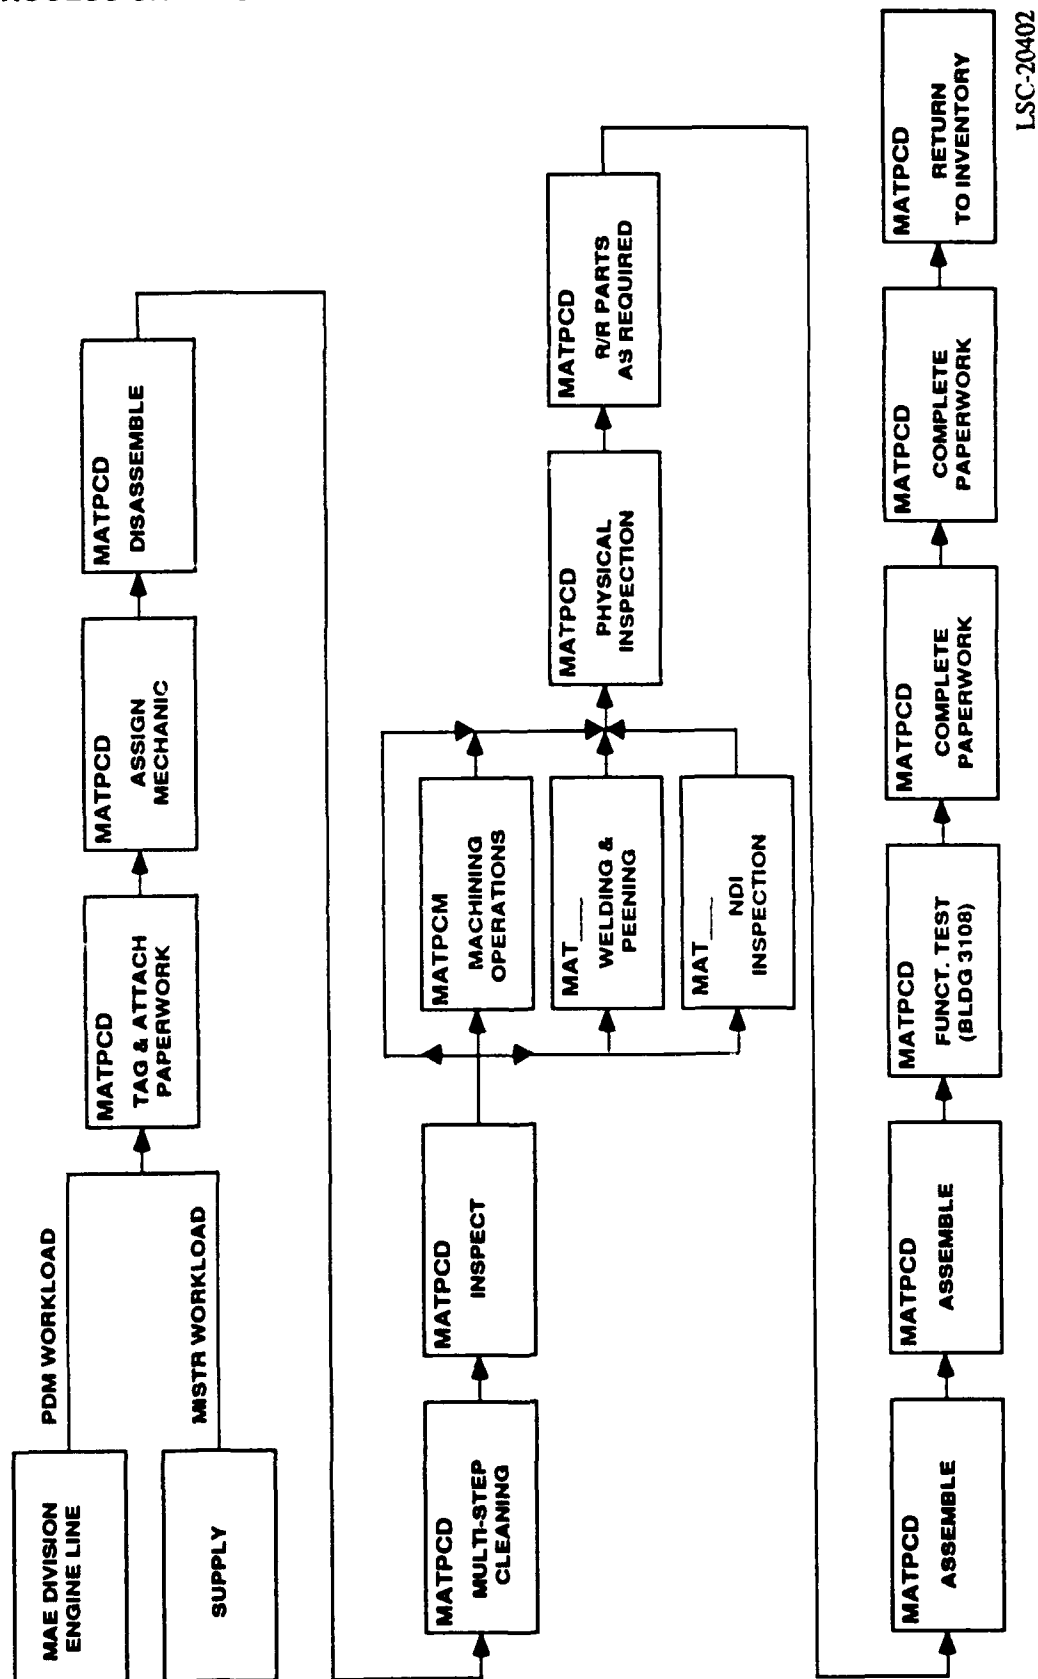
LSC-20402

MATPCD ENGINE ACCESSORIES — NOZZLE ACTUATOR
FIGURE 6.9.1-4

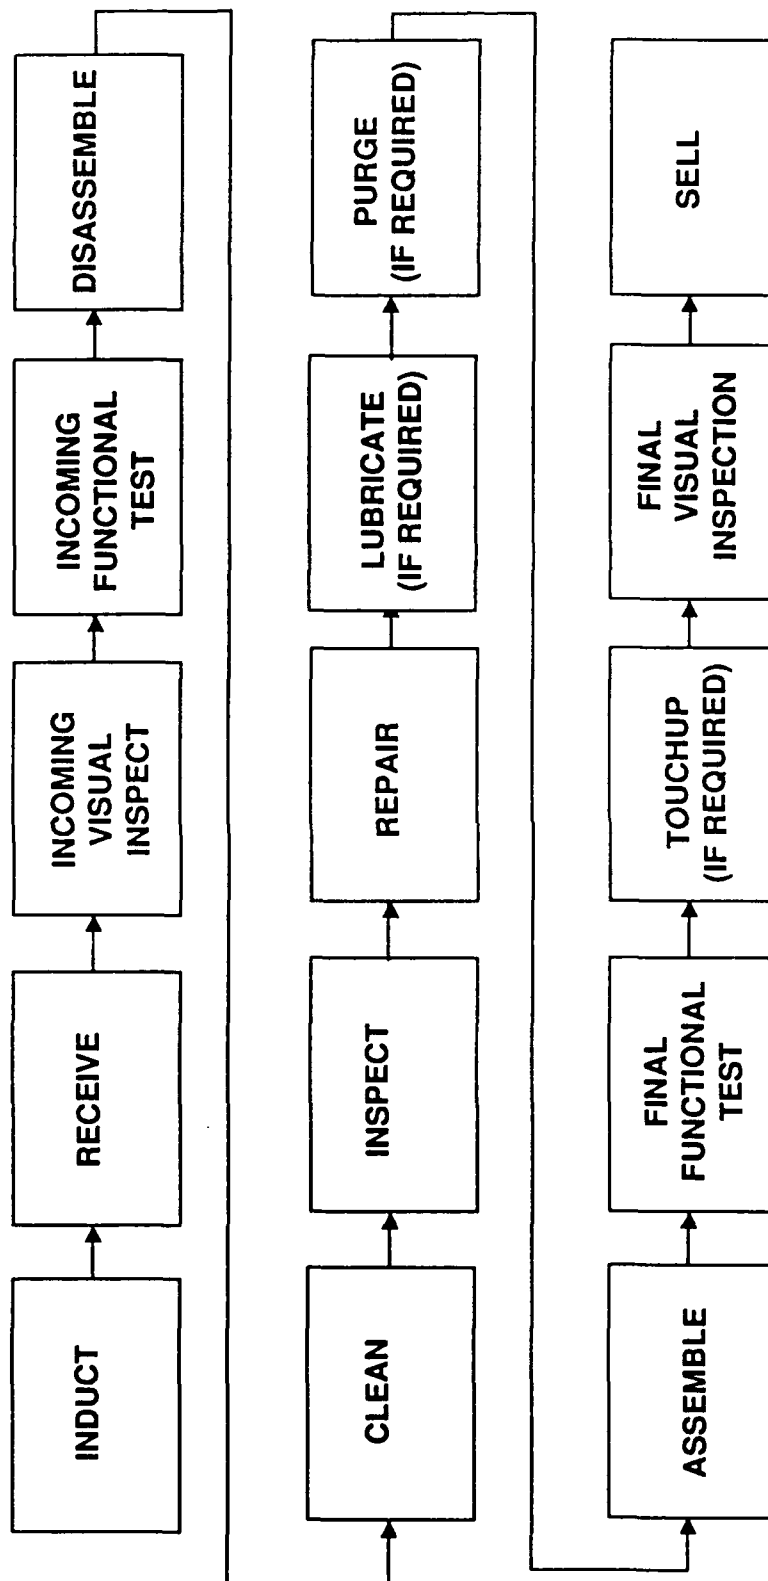
LSC-20428

OC-ALC MATPFA PROCESS FLOW CHART
FIGURE 6.11.1-1

diagrams showing the flow of typical items through MATPFA are shown in Figure 6.11.1-1 and Figure 6.11.1-2. In addition, the workload in this RCC is highly variable, with significant changes in the quarterly requirements for a PCN fairly

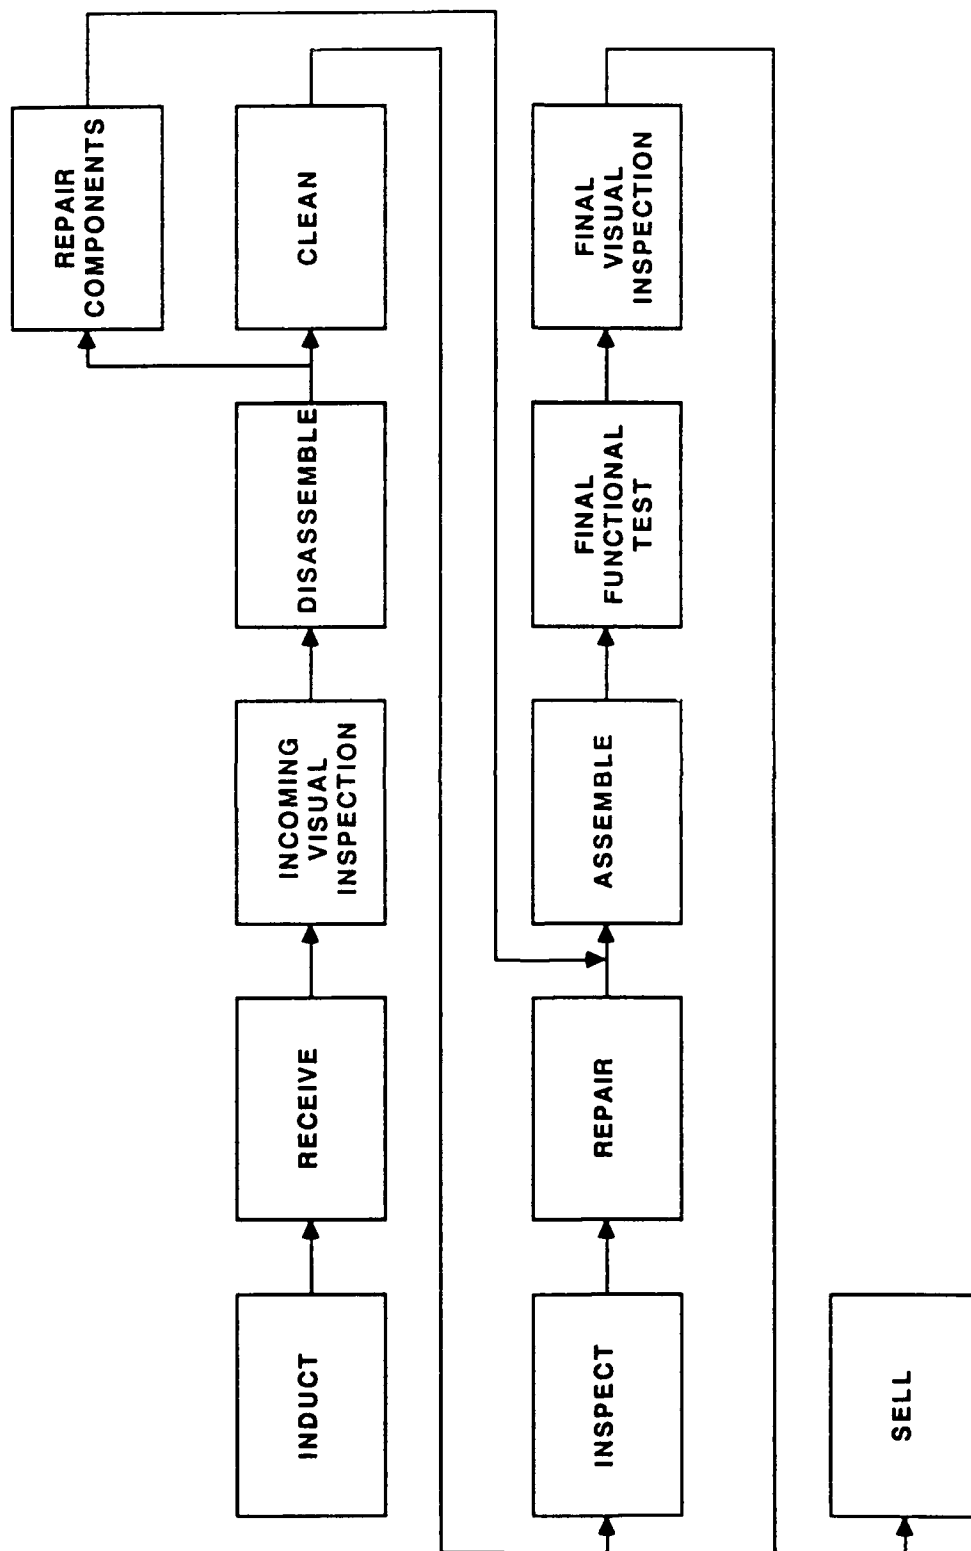
LSC-20323

**OC-ALC MATPFA PROCESS FLOW
(FOR ITEMS WHERE COMPONENTS ARE WORKED SEPARATELY FROM THE END ITEM)**
FIGURE 6.11.1-2

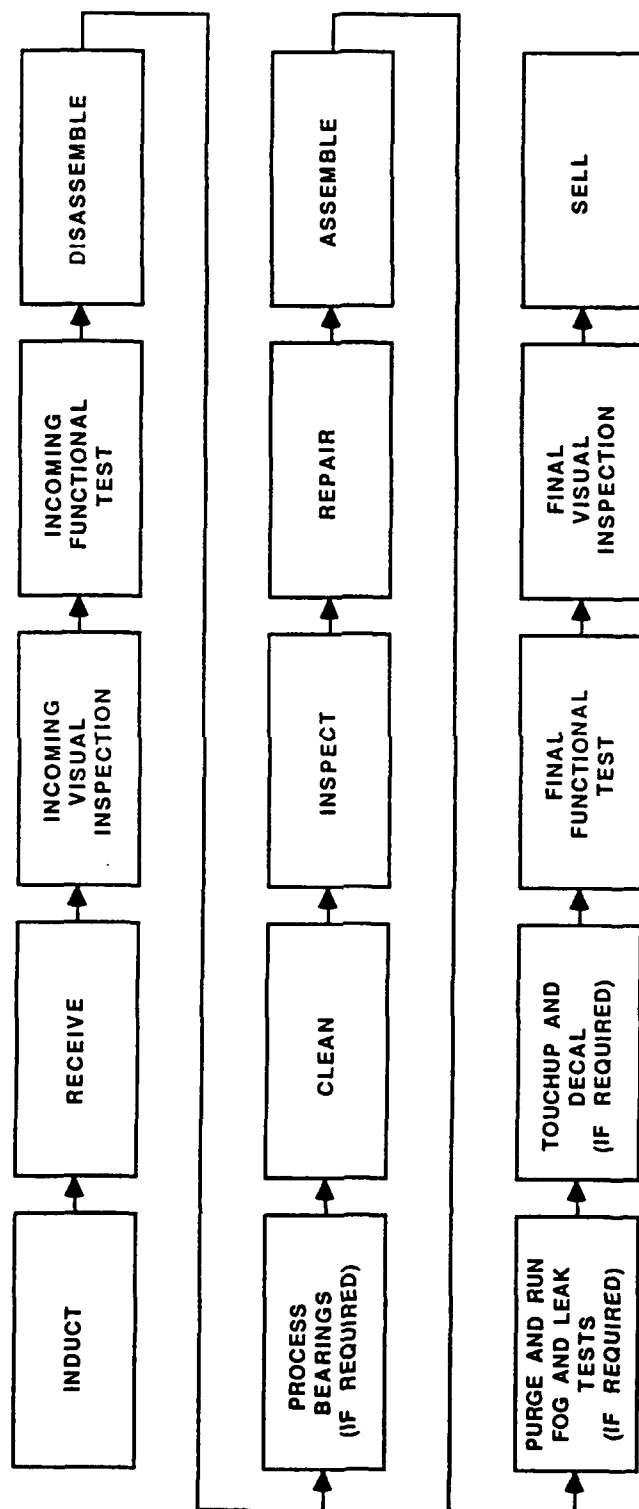
LSC-20248

**OC-ALC MATPFE PROCESS FLOW
FIGURE 6.12.1-1**
